# Service Manual 643WK

## Siemens-Telefunken, Choral (Dutch version)

Year of manufacture: 1936/1937

© Ing. Viktor Cingel, CSc. 11/2010 (SK), translate Ben van der Klugt 16-10-2017 Waddinxveen (NL)

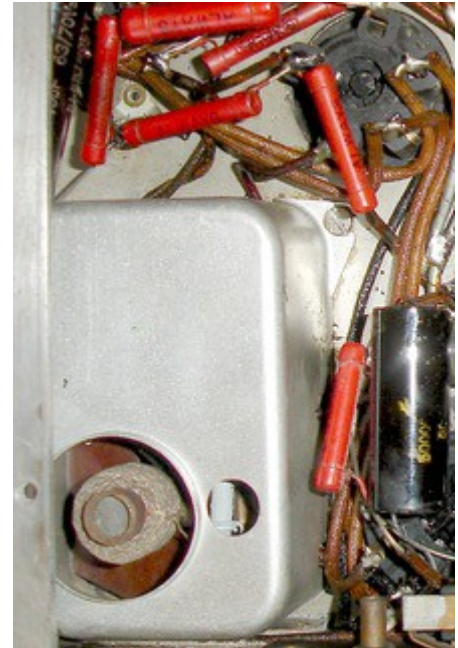
## The design of the MF band filter in the anode AF3

In this pictures are the graphics MF filter illustrated and the cover of the detector circuit. C23 was probably defective because it was necessary to connect a capacitor of 120pF parallel to it, with the C23 exactly match L17 on 484 kHz. In this original version, the circuit are in an aluminum shielding enclosure. Inside the trim hole you can see the ceramic capacitor..

1. First, in any circuit L17/C23. Trimmer C23 was mysteriously without capacity, the coil L17 which was calculated to 664μH on the MF frequency 484kHz capacitor C23 = approx. 162pF.

I estimate the Trimmer on 50pF and put a 120pF ceramic capacitor in parallel. The picture is the inside of the filter under the aluminum housing and feeding the modulated 484kHz on the grid.

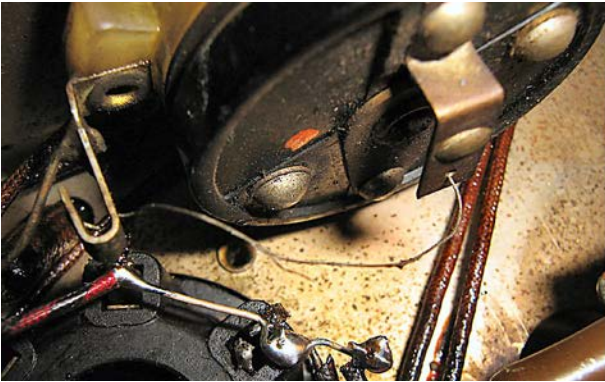
C34 with defect metal center wire.

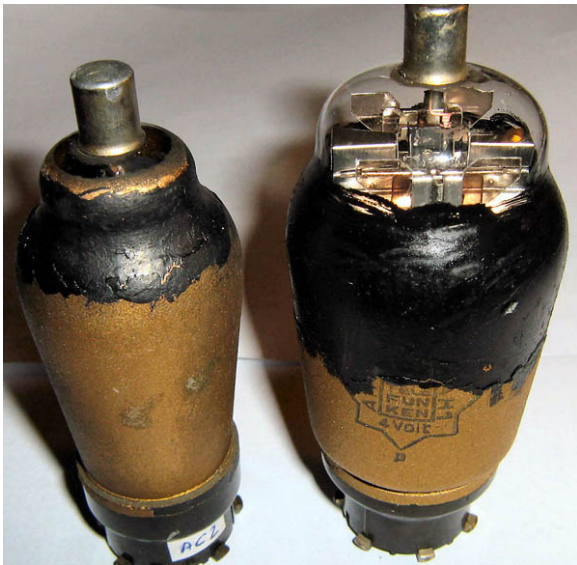
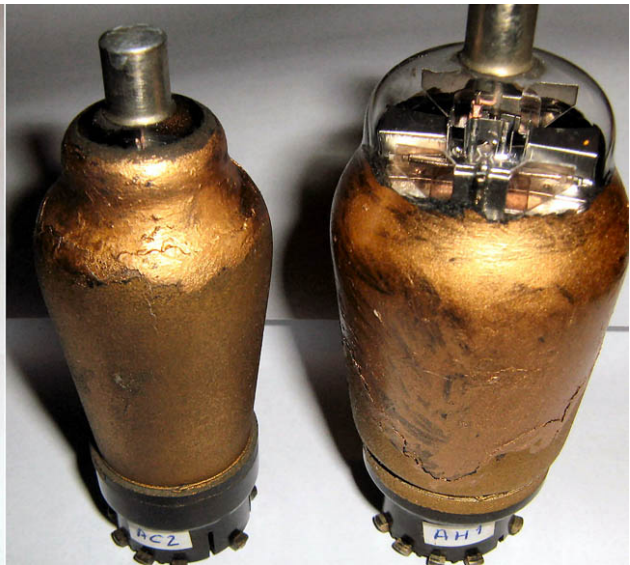
Shielding of AH1 and AC2 were bad, repair with conductive paint and gold paint, not nice but efficient.
